EVALUATION OF THE IMPACT OF THE MINES DEVELOPMENT, INCORPORATED MILL ON WATER QUALITY CONDITIONS IN THE CHEYENNE RIVER

ENVIRONMENTAL PROTECTION AGENCY

SEPTEMBER 1971

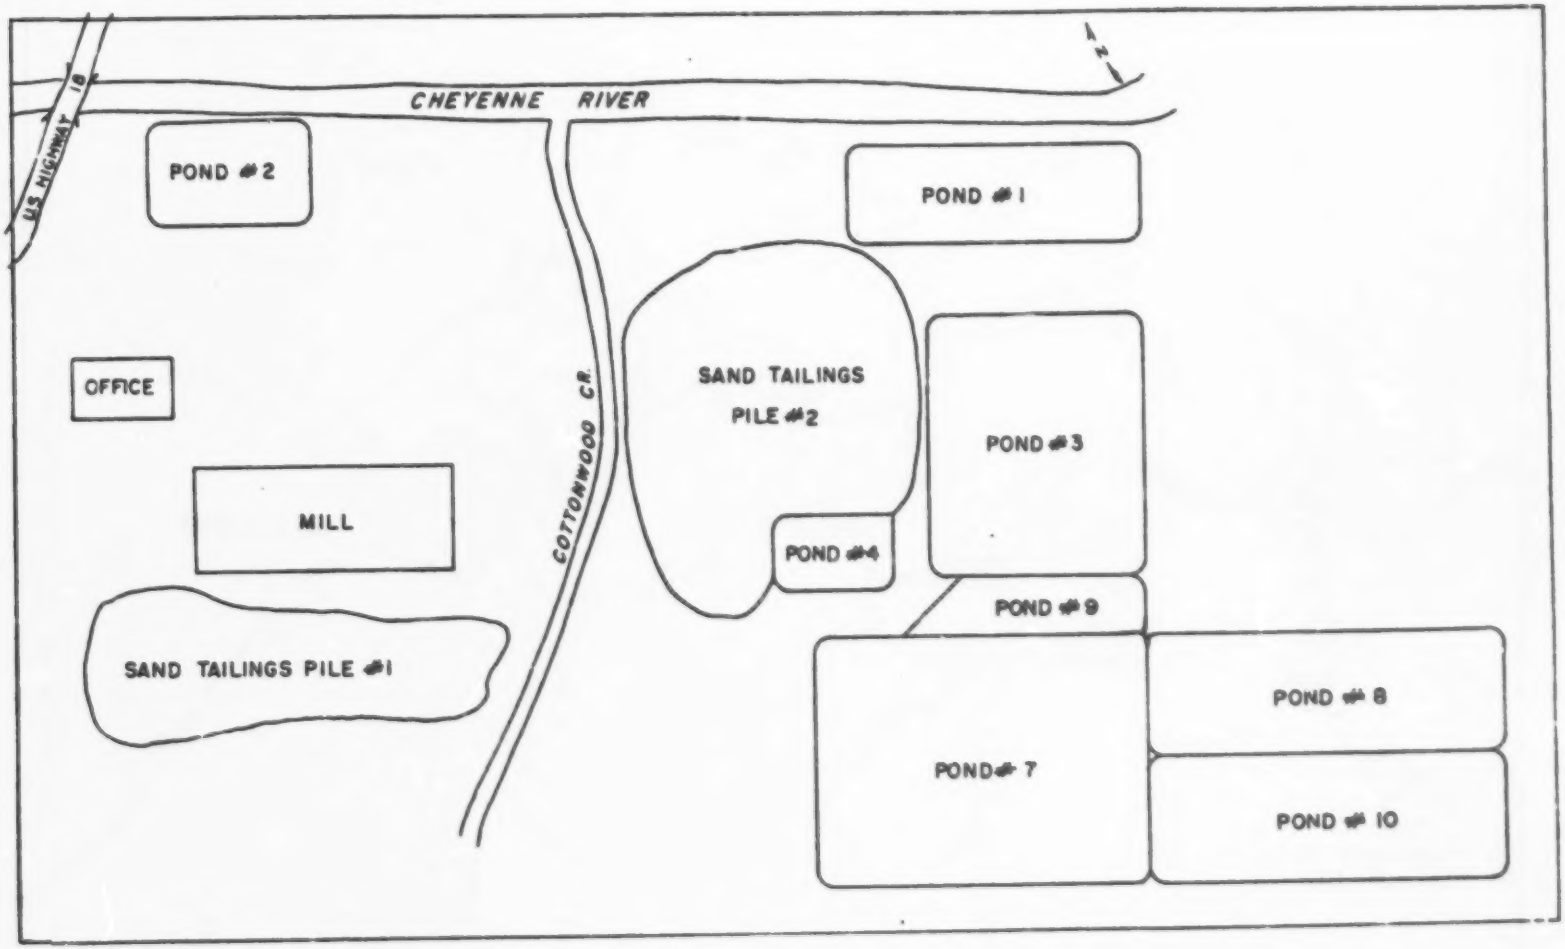
MINES DEVELOPMENT, INC.
URANIUM MILL
PROCESS PONDS AND TAILINGS PILES
FIGURE 2

Based on visual observations, sand tailings from the three storage areas (Pile No. 1, Pile No. 2, and Pond No. 2) are entering the water environment by wind and/or water errosion. Such off-site losses of these high-radioactivity solids is most undesirable and should be curtailed at an early date.

The waste management program conducted by Mines Development essentially provides for the on-site retention of liquid and solid wastes with no direct release to the water environment. Briefly, liquid wastes from the uranium and vanadium extraction circuits are discharged to a system of process ponds wherein volume reduction occurs by evaporation and seepage. Seepage losses are the result of pond excavation in a zone of permeable soil. In order to control the total volume of required ponding, water is recycled for use as process water. Sand tailings are stored in two unstabilized piles and two retention ponds. An areal schematic showing the locations of the ponds and the sand tailings piles is presented in Figure 2.

1. Slime tailings and sand tailings from the uranium circuit are discharged to Pond No. 7, a pond functioning as a retention and sedimentation basin.
2. Clarified vanadium-bearing liquor (blue liquor) is pumped to Pond No. 3.

1. The bottom and sidewalls of the retention ponds should be sealed to eliminate seepage into Cottonwood Creek and the Cheyenne River.
2. A two phase program providing for the stabilization and ultimate disposal of sand tailings should be developed with a reasonable timetable for implementation. As a first phase, immediate action should be taken to stabilize the huge bulks of sand tailings stored in Pile No. 1, Pile No. 2, and Pond No. 2 against wind and/or water errosion. The most desirable alternative for the second phase of the program, ultimate disposal, seems to be storage in the excavated portions of the open-pit uranium mine operated by Mines Development, Inc.
